15. Supplementary Notes			
16. Abstract  About 11:06 p.m. on June 5, 1975, a Reading Company commuter train struck a tractor-semitrailer (truck) at a grade crossing near Yardley, Pennsylvania. The truck was transporting three coils of steel, two of which penetrated the first commuter car. The three occupants of the lead car were killed and an occupant of the second car was injured slightly. The truckdriver was uninjured. The semitrailer was torn from the tractor and damaged beyond repair and the lead commuter car was damaged extensively.  At the time of the collision, the automatic grade crossing signal system was functioning. The truckdriver said he had not seen or heard the warning signals.  The National Transportation Safety Board determines that the probable cause of the accident was the failure of the truckdriver to stop the truck in accordance with the warning signals.

About 11:06 p.m. on June 5, 1975, a Reading Company commuter train struck a tractor-semitrailer (truck) at a grade crossing near Yardley, Pennsylvania. The truck was transporting three coils of steel, two of which penetrated the first commuter car. The three occupants of the lead car were killed and an occupan

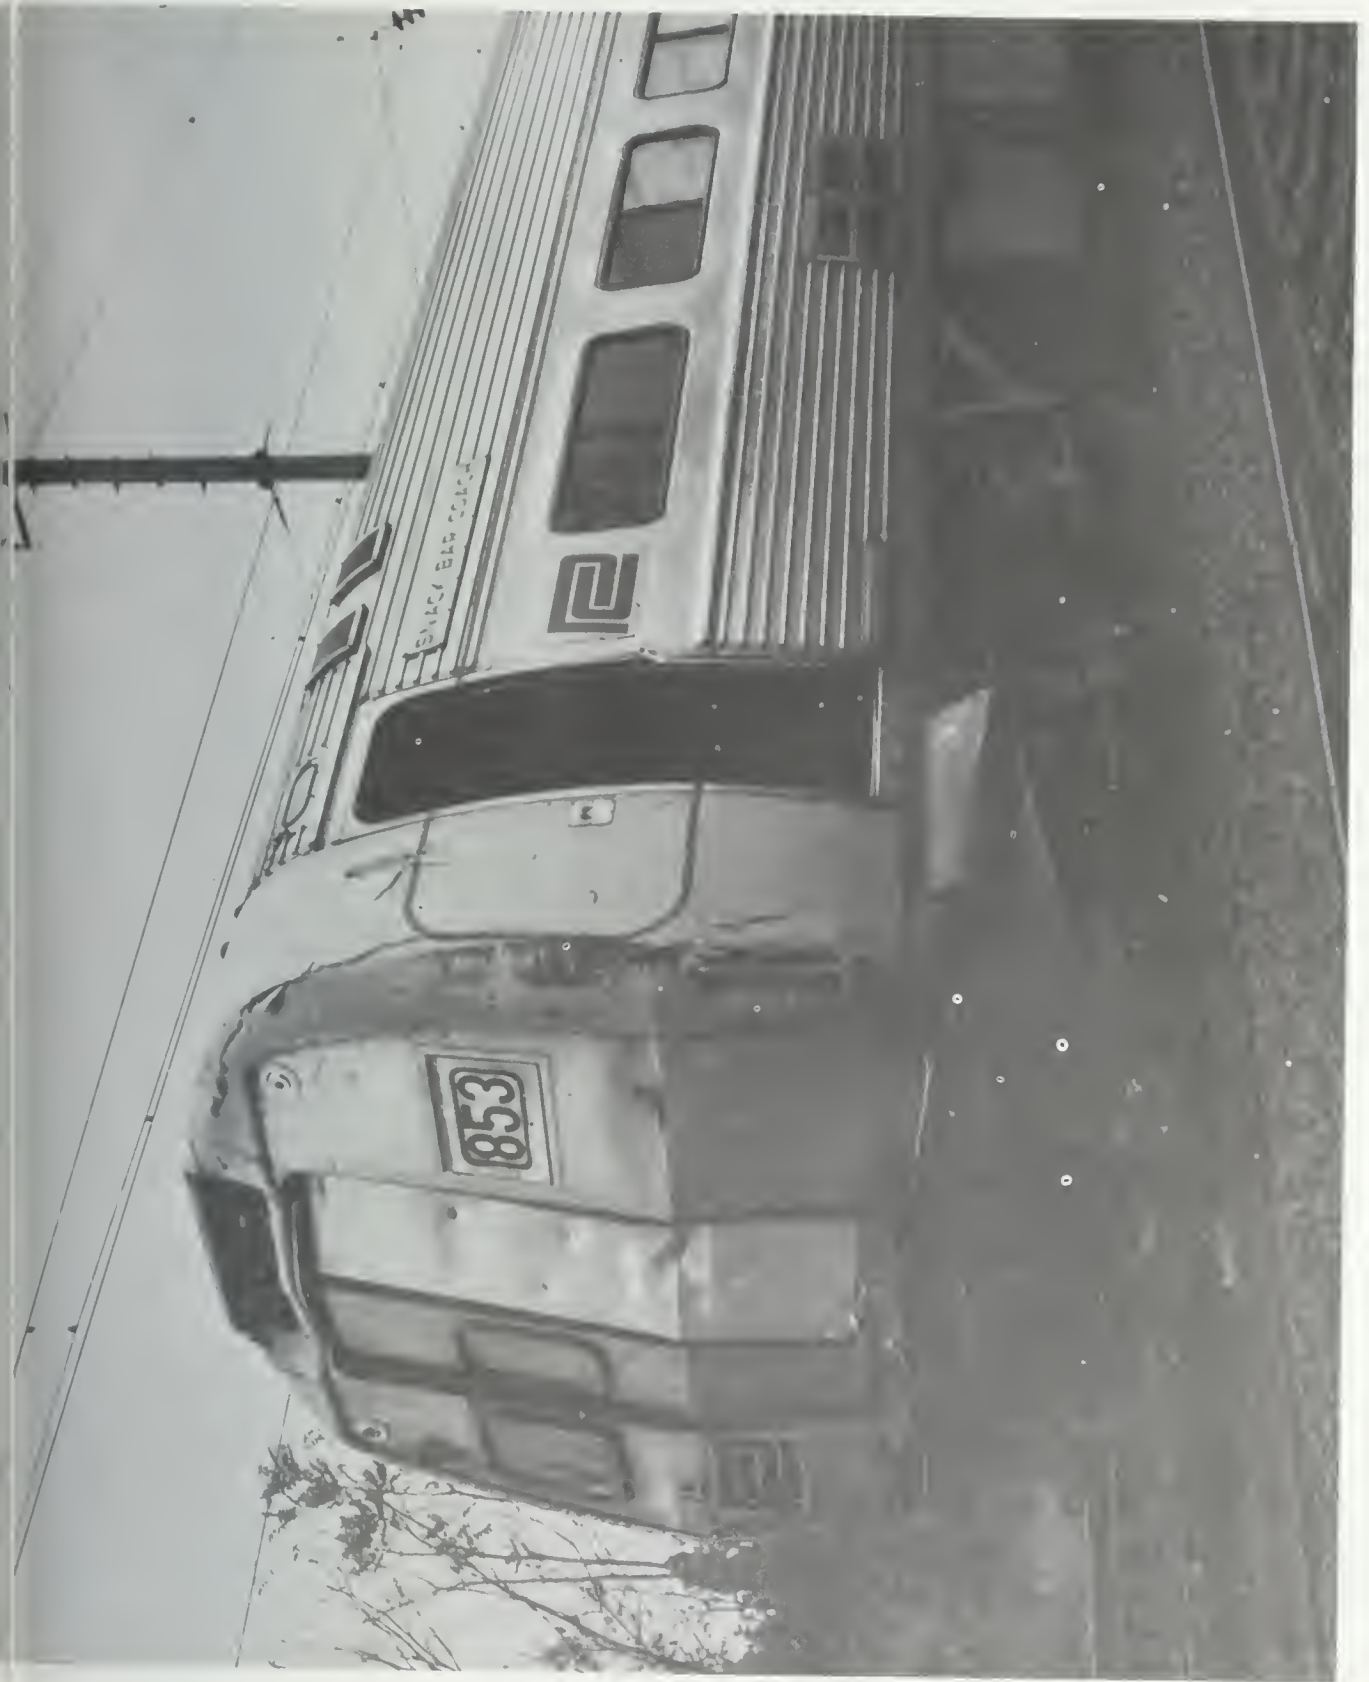
Figure 3. Last car of No. 132.

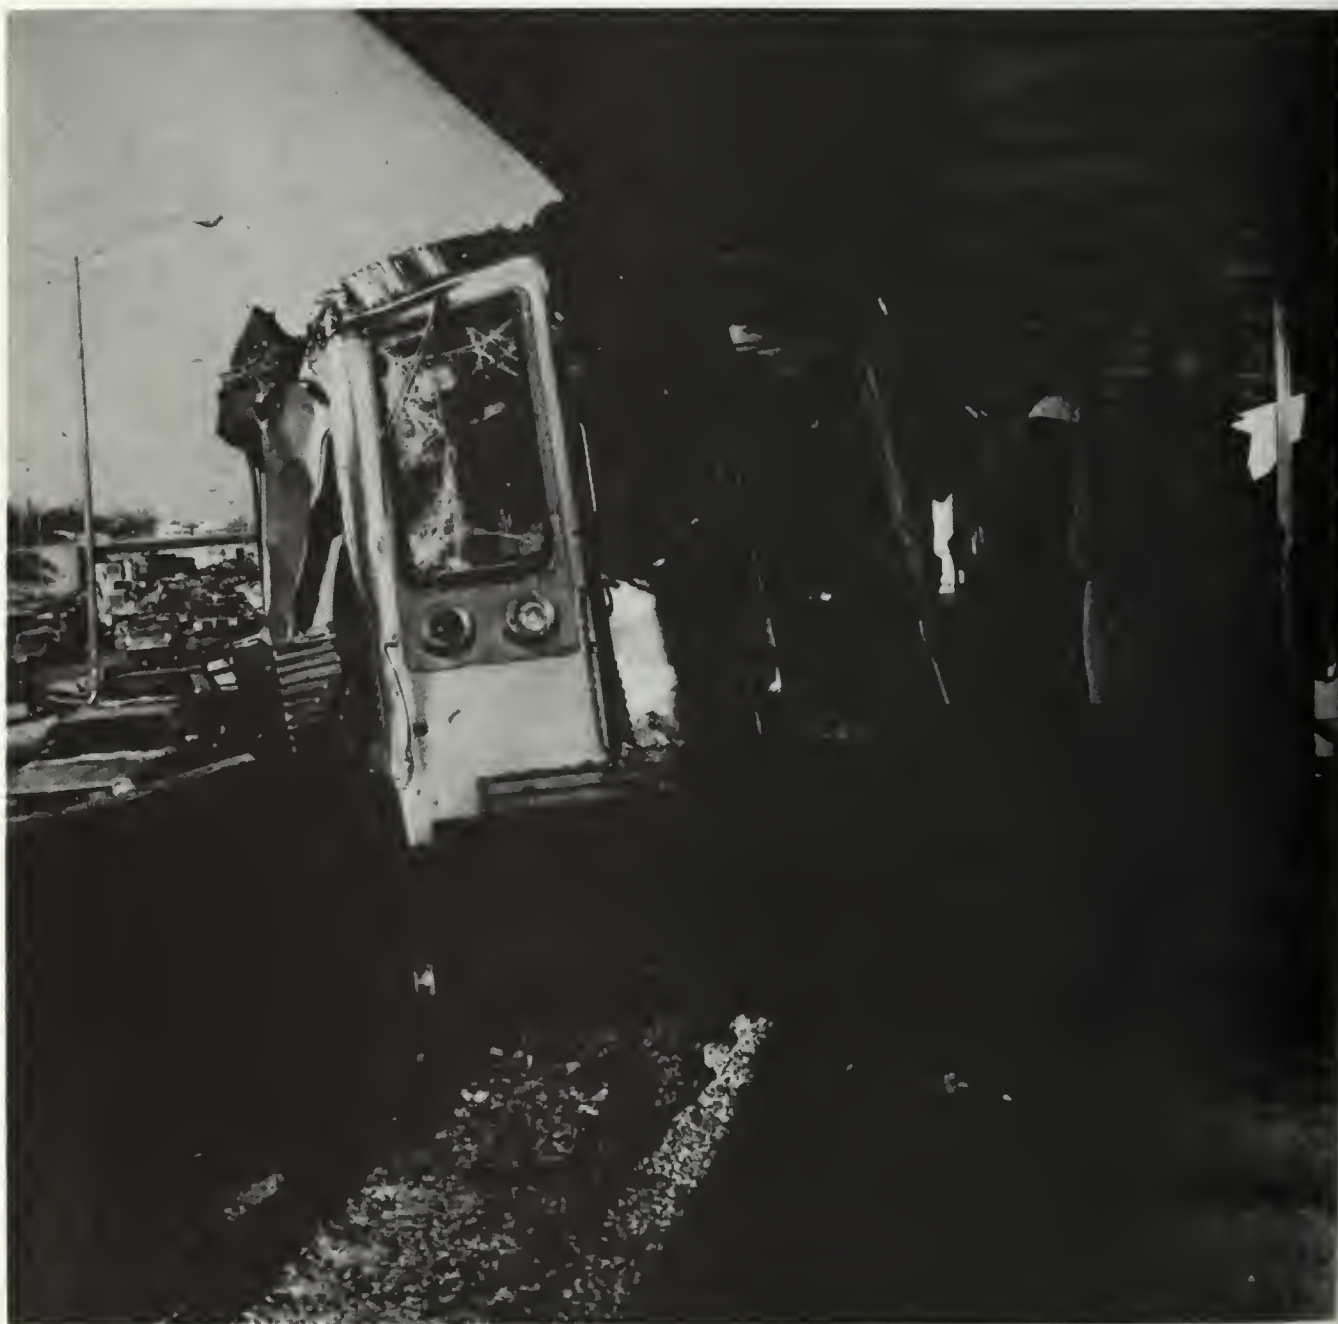
Figure 5. Train No. 315, Car 2308, after the impact.

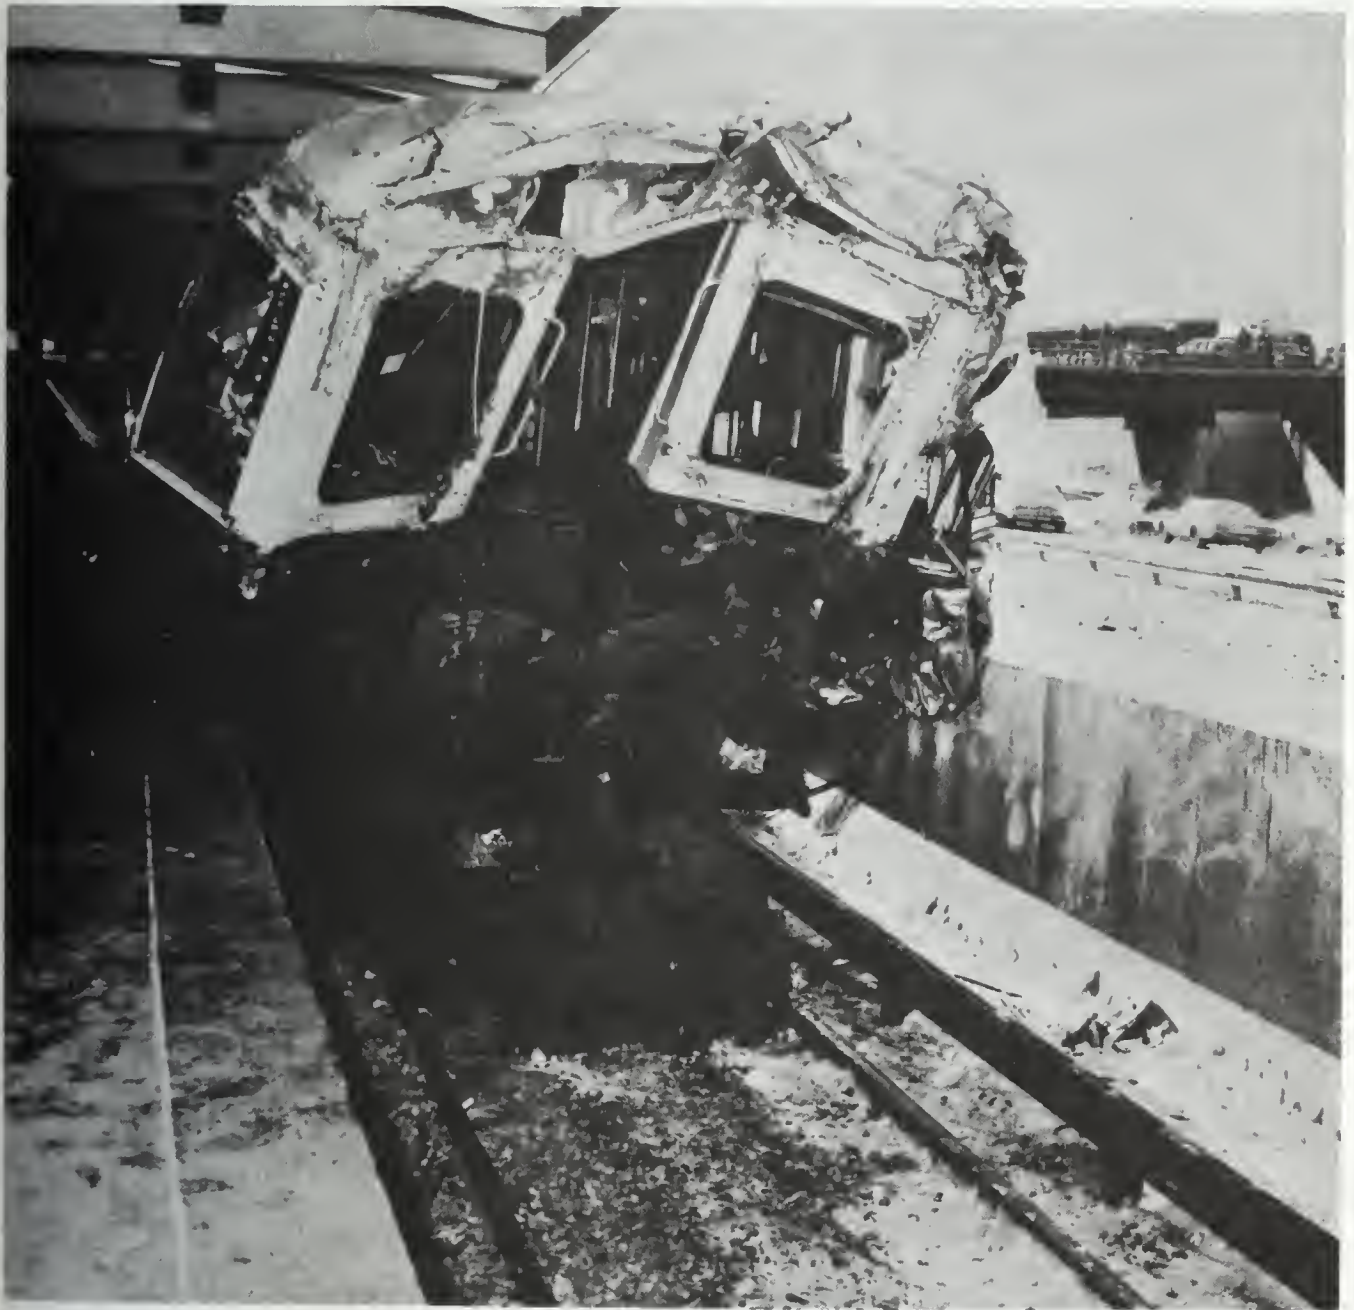
Figure 6. Train No. 104, Car 6583, after the impact.

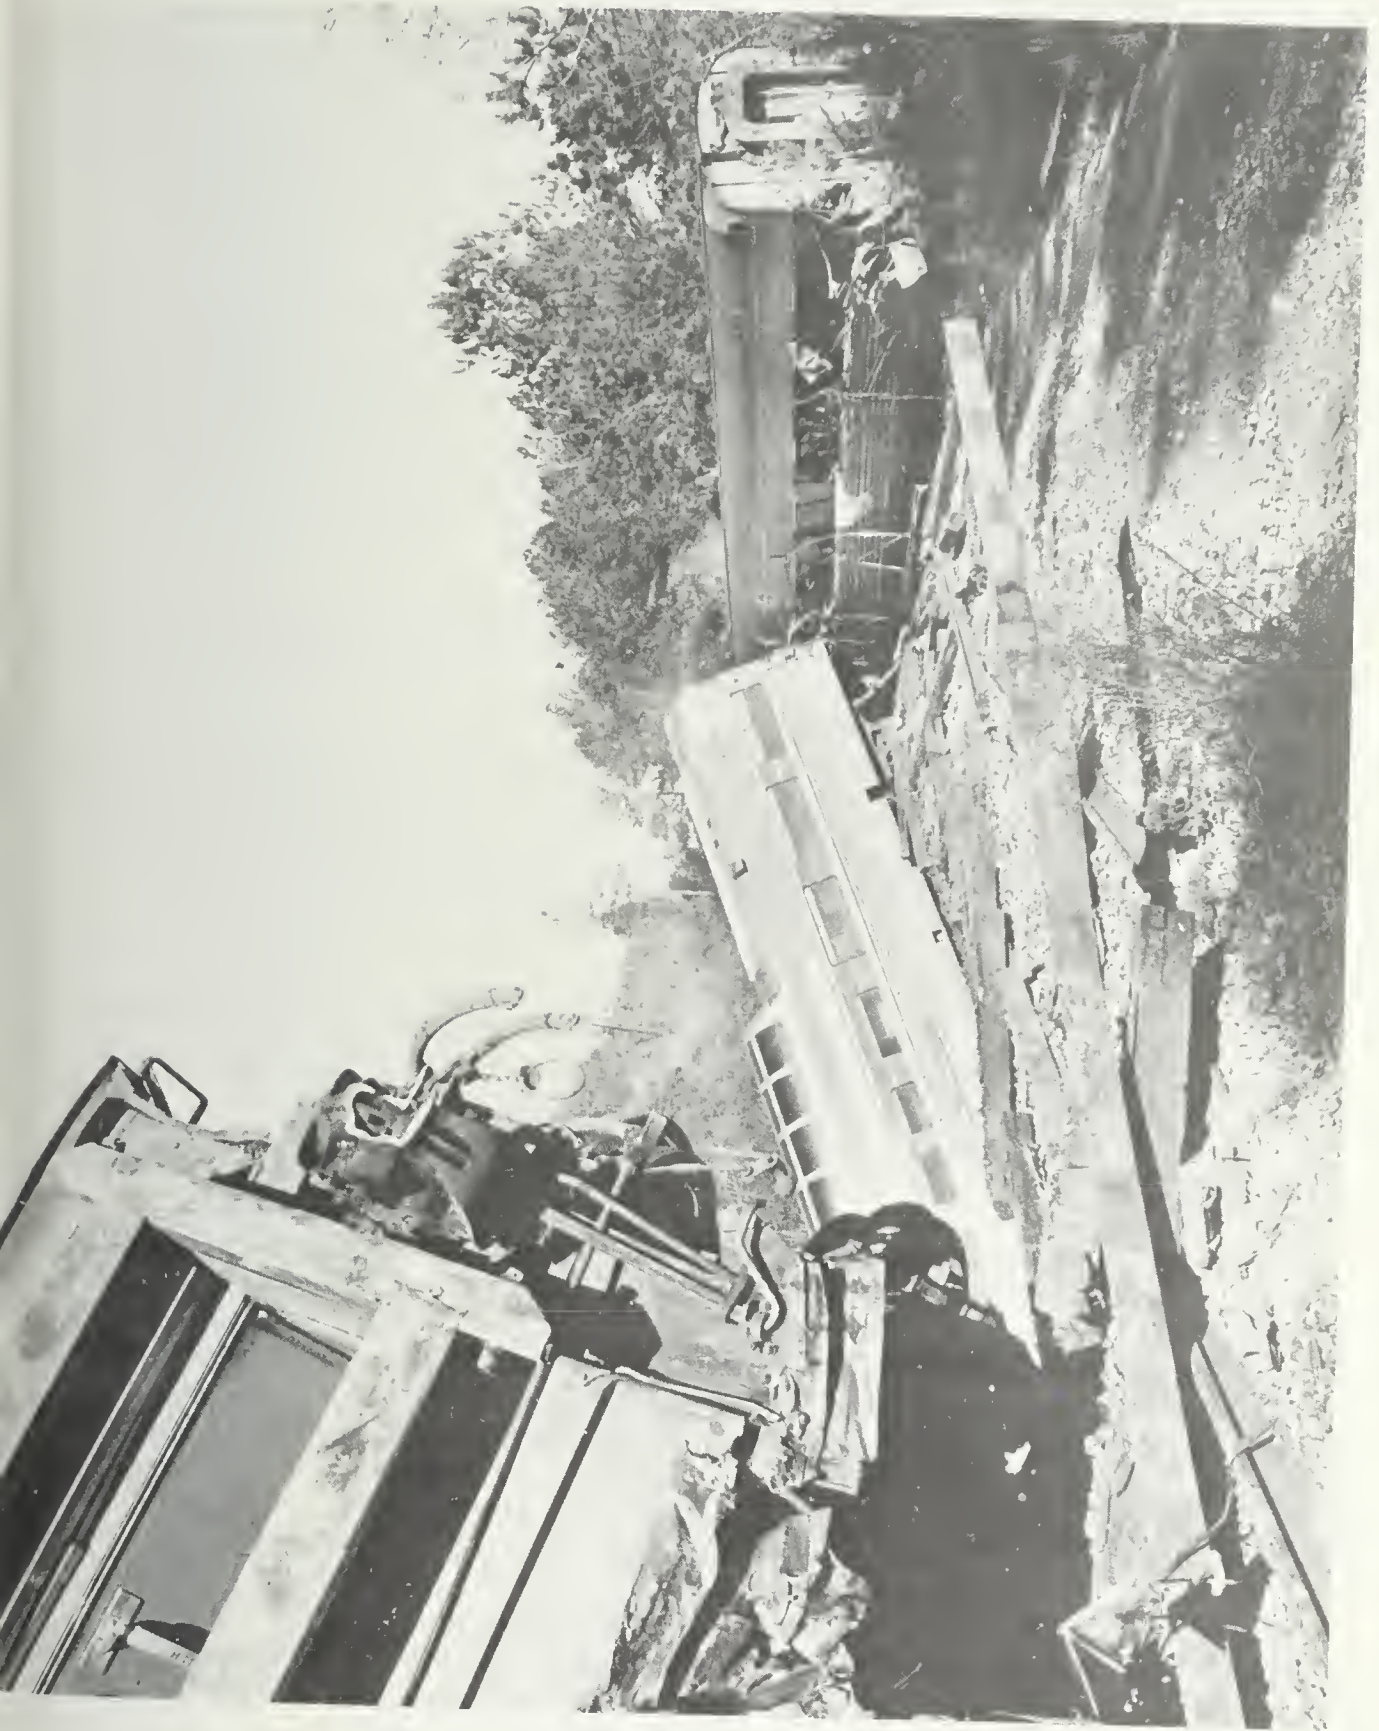
Figure 2. Damaged seventh and eighth cars (background) of train No. 315.

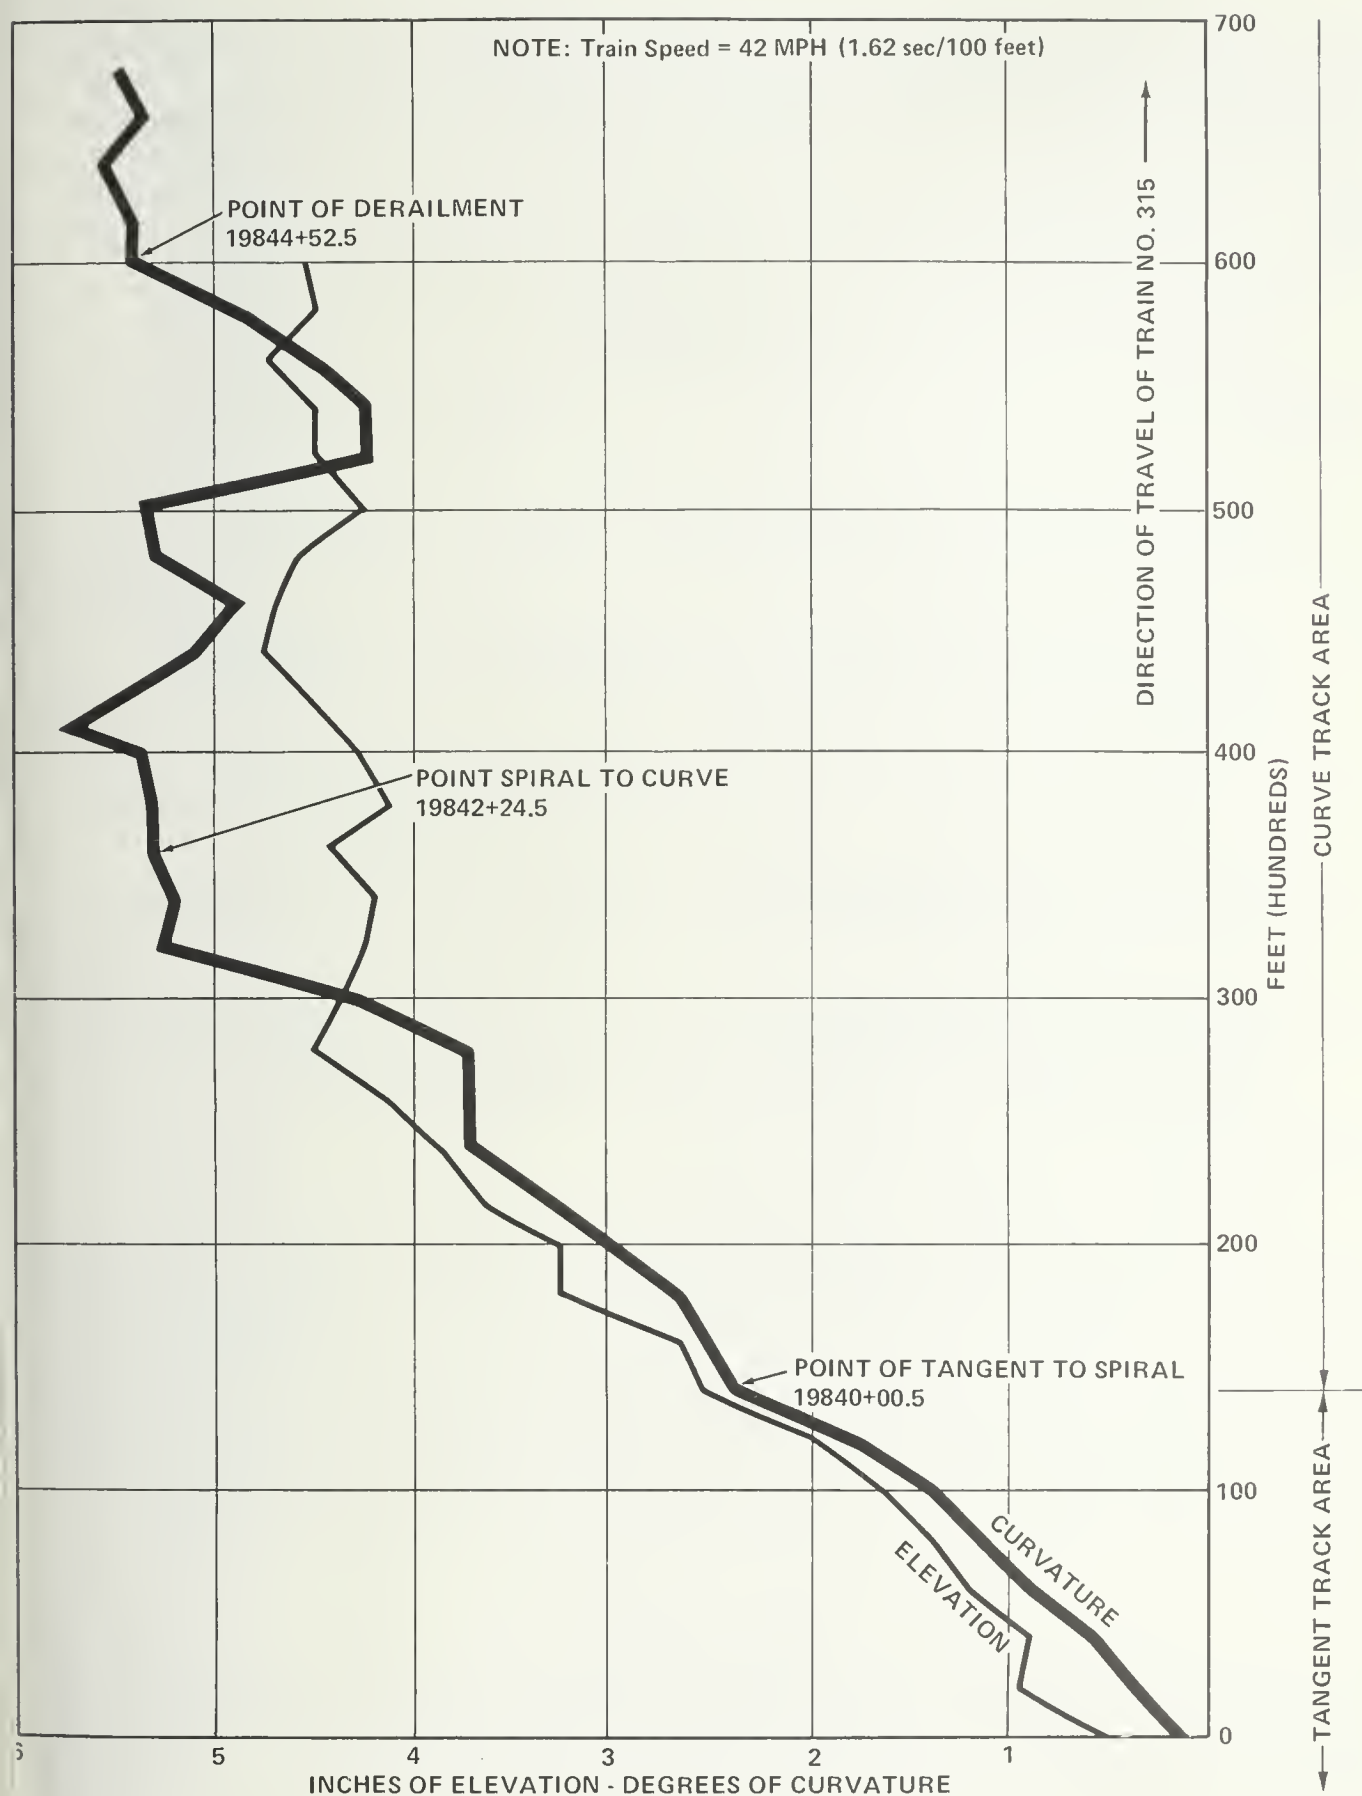
Figure 3. Deviations in curvature and superelevation.

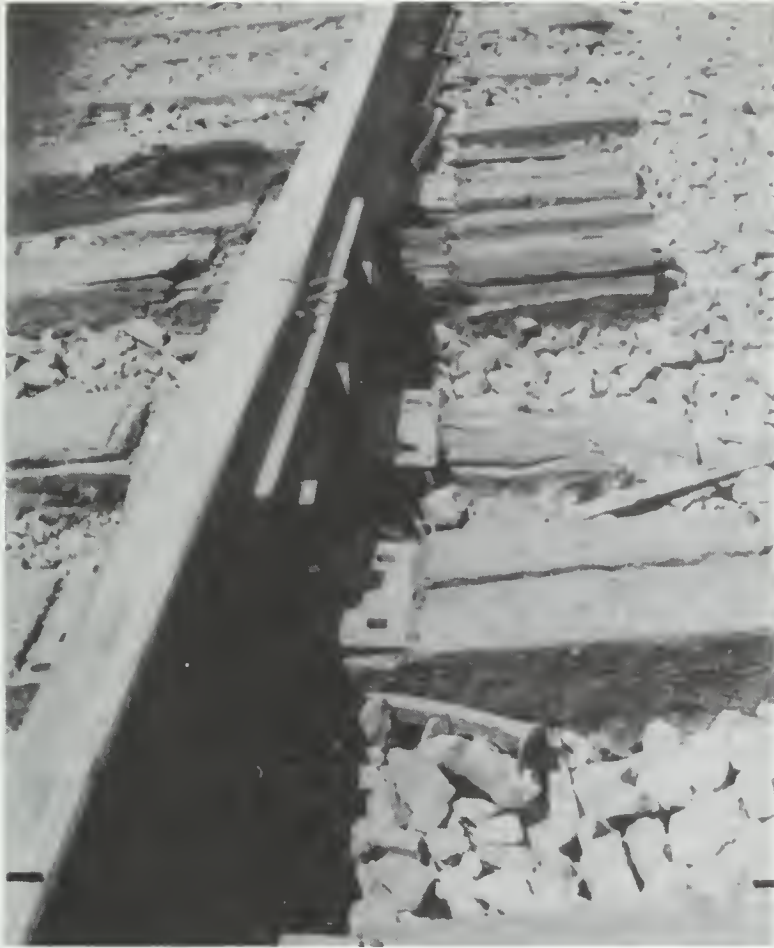
Figure 2. Defective crossties about 700 feet west of derailment point.

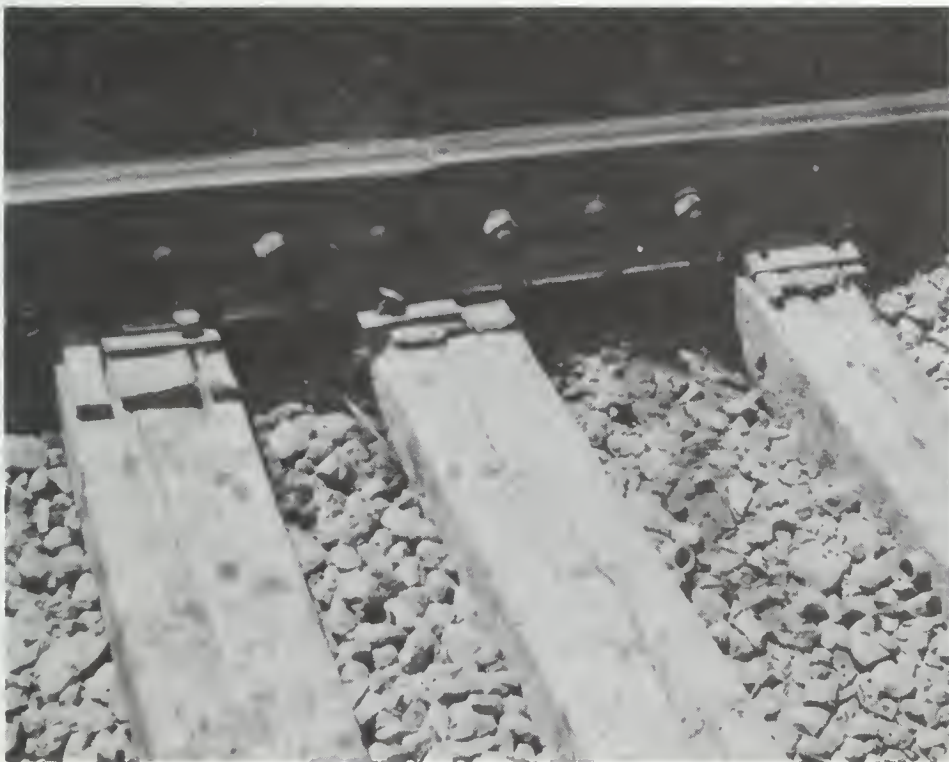
Figure 3. One of several joint locations with shims under tie plates.

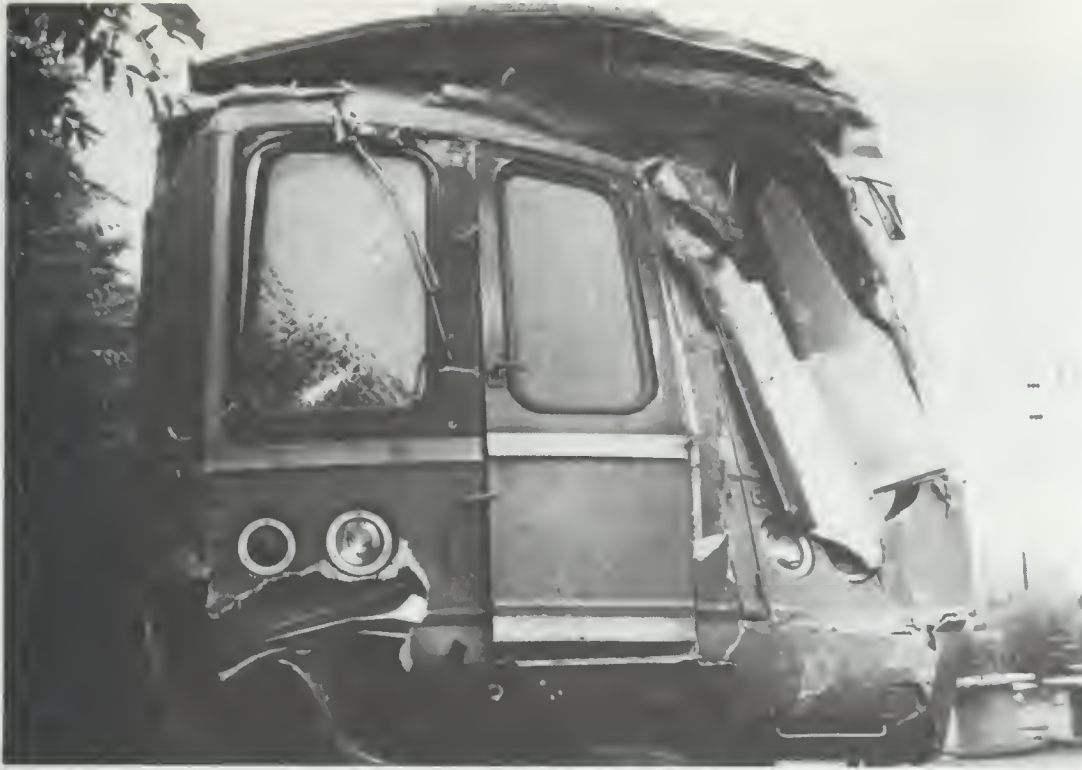
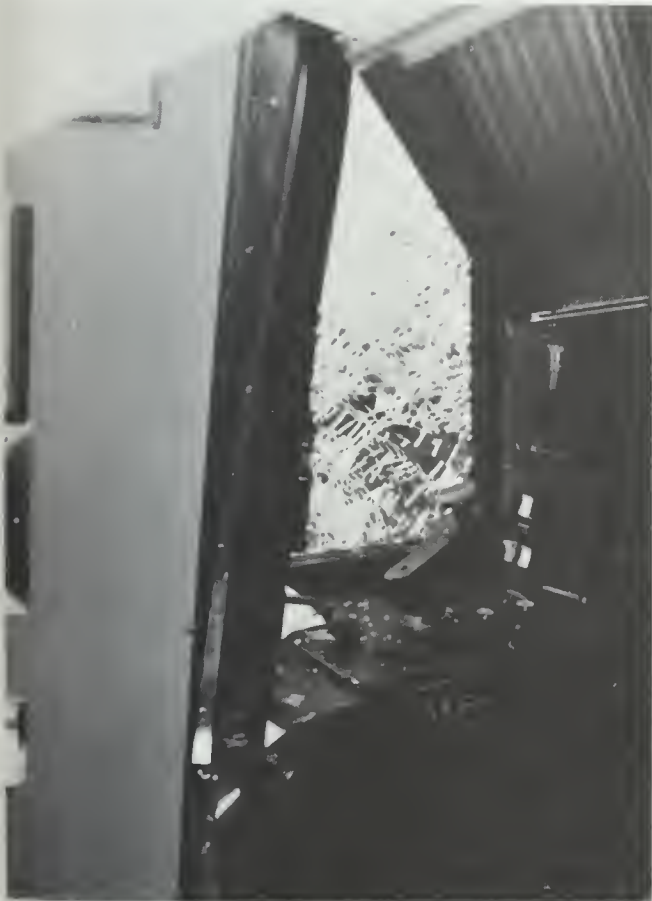
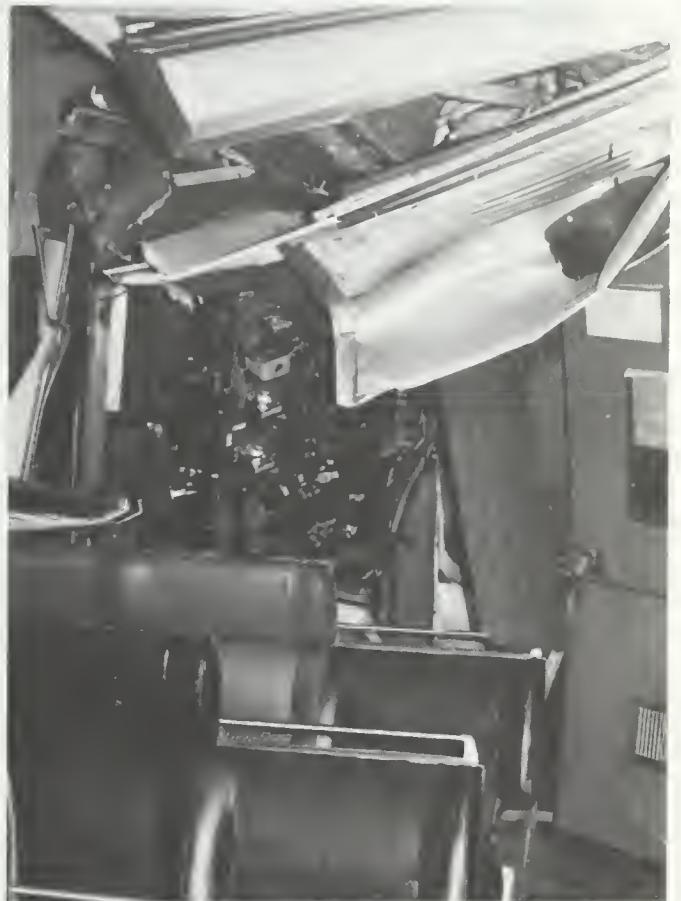
Figure 2. Damaged rear end of No. 1992 (top) interior view of cab (bottom left) interior view of rear of No. 1992 (bottom right).

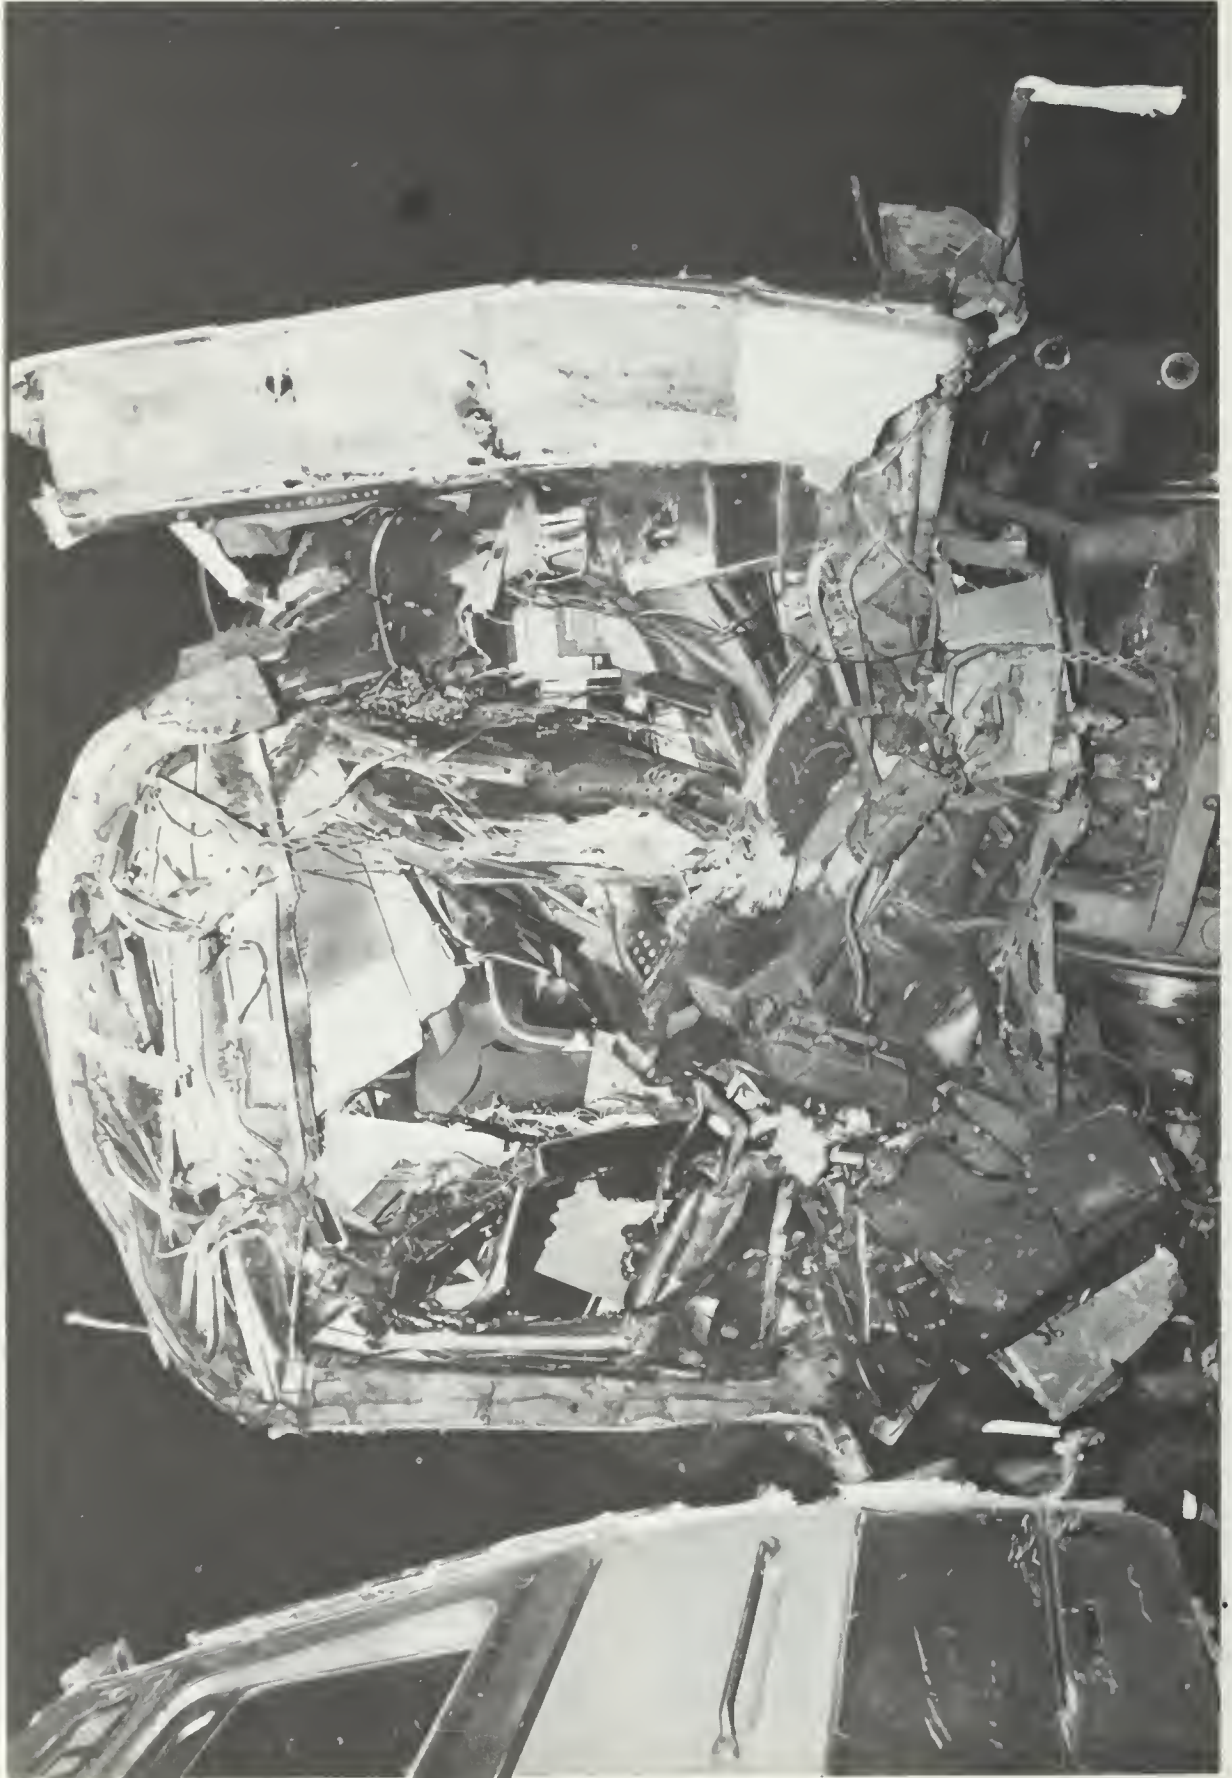
Figure 3. Damaged lead car of train No. 1994.

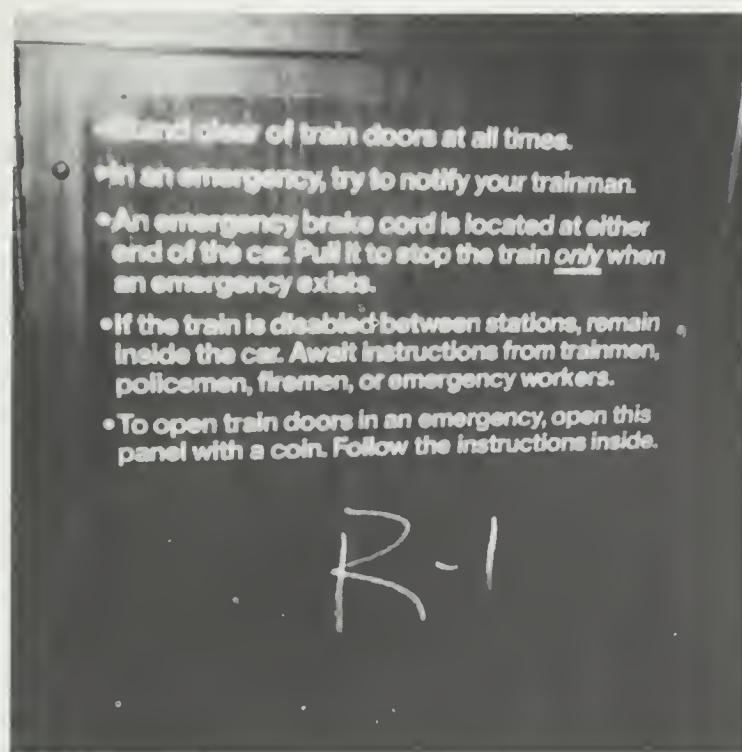
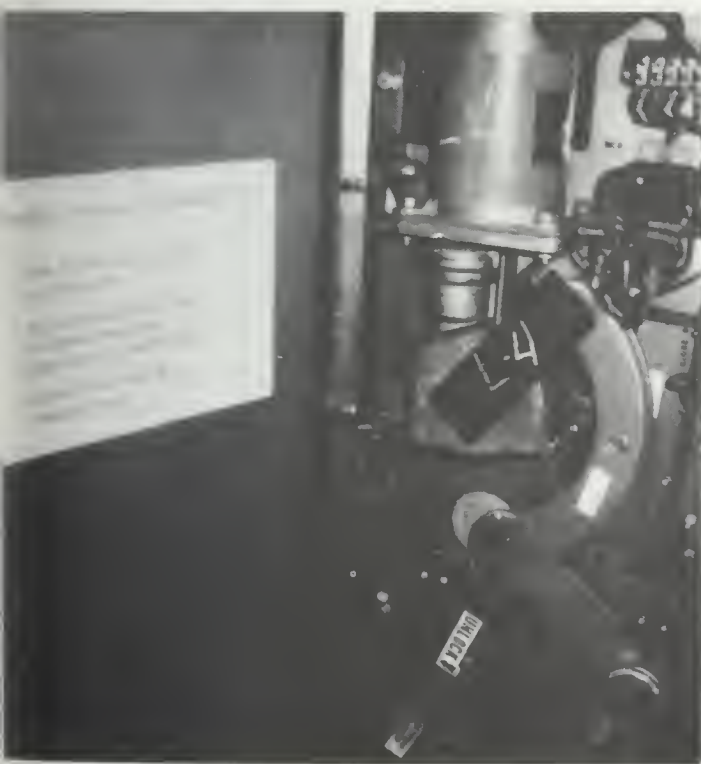
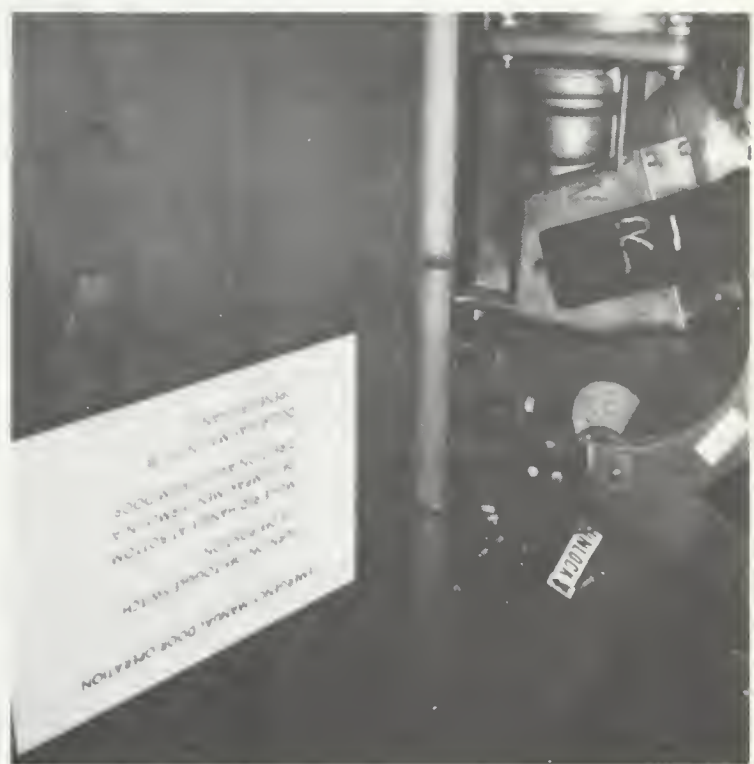
Figure 4. Emergency instructions on outside of compartment door containing manual door operation equipment (top) with instructions mounted properly (bottom, left) and mounted improperly (bottom, right).

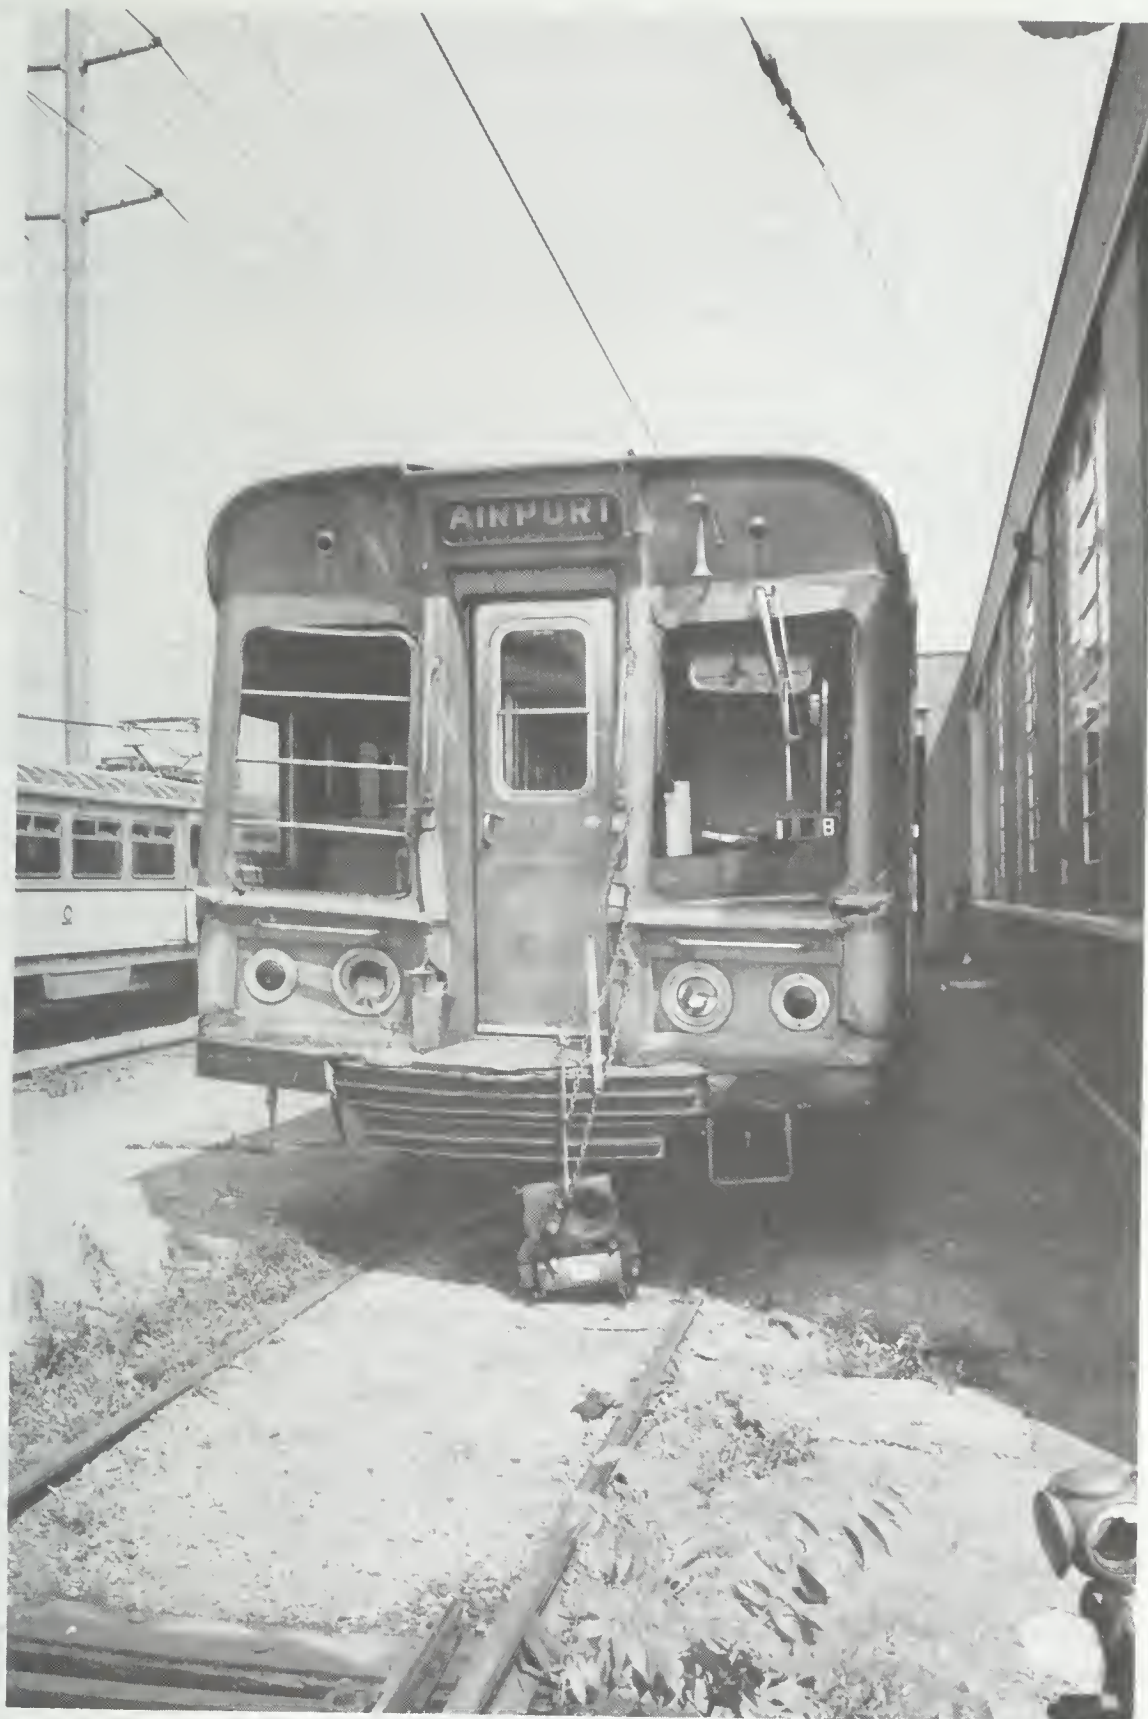
Figure 2. Damaged end of car No. 164 of train No. 409.

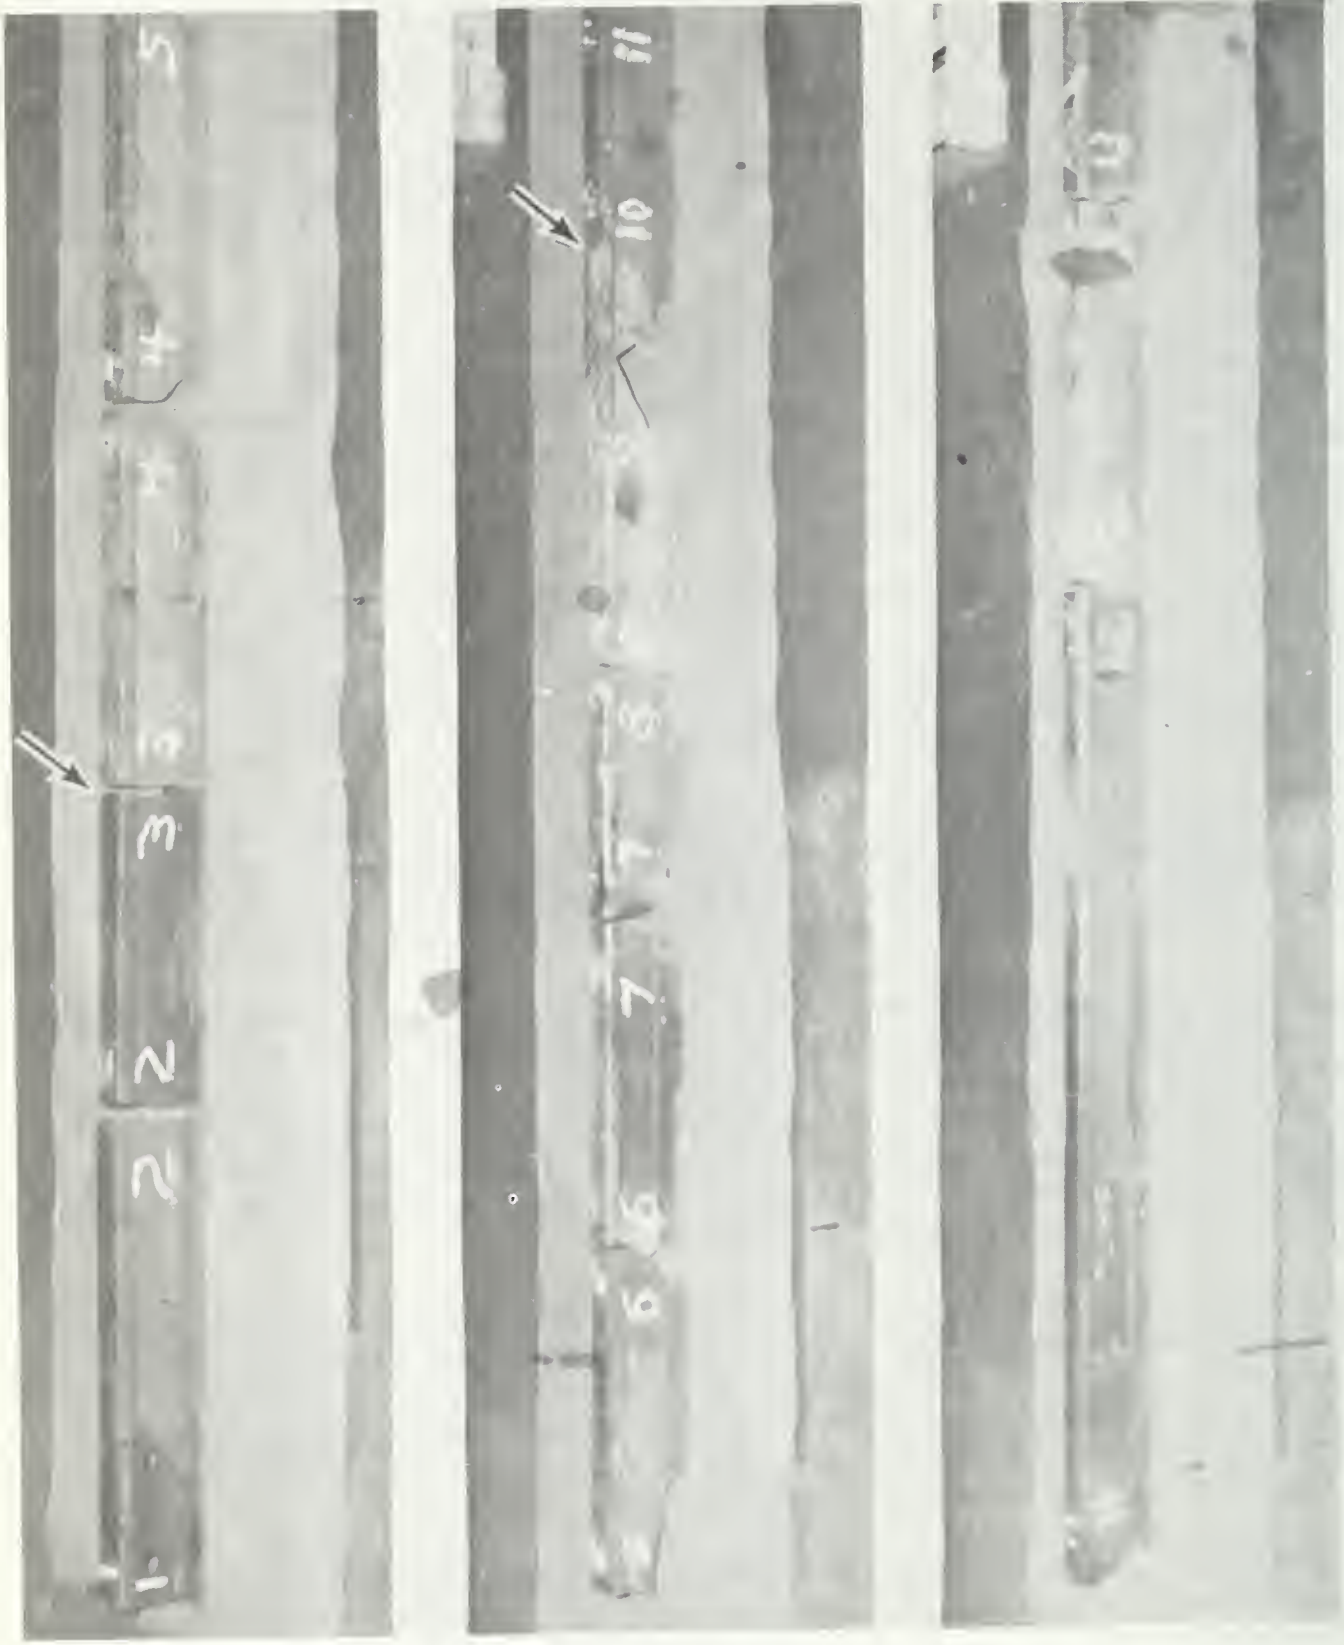
Figure 2. Broken sections of 33-foot rail. Arrow indicates point of initial failure.
